**Flood Control Project Maintenance
Levee Inspections**

Fall 2016 Levee Maintenance Deficiency Summary Report

Sacramento River Basin

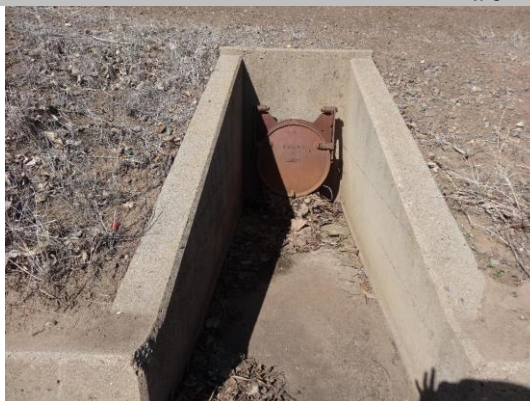
Photo 1 of 2 : UCIP_FA_2016_32044_58543.jpg

WS view: U typed concrete headwall, pipe, and flapgate on levee slope.

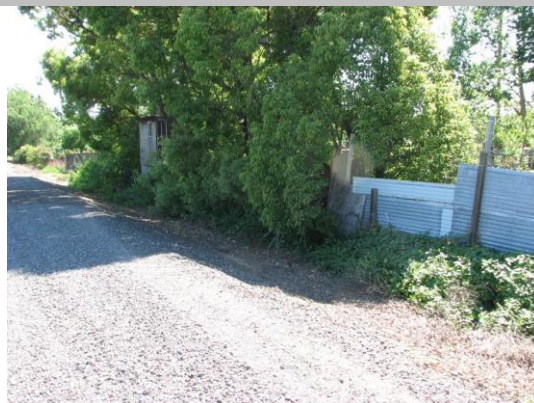
Photo 1 of 1 : FA_2016_NA0003_64_40_20160823_00024.jpg

LM Start	2.06	Rating **	U	Issue No.	40
LM End	2.08	Issue Type +	En	Location *	LS
Category	Earthen Levee			GPS Latitude/Longitude	
				Start	End
Item	Encroachments			39.749145 °	39.749461 °
				-121.918506 °	-121.918425 °
DWR ID	DWR_NA0003_01_s_2016_40				
Comment Code					
FE : Fence					
Inspector Comment					
Piecemeal corrugated fencing with vegetation completely obscuring landside toe. Small fort included along fencing.

View of a metal fence and treehouse obstructing visibility and access.

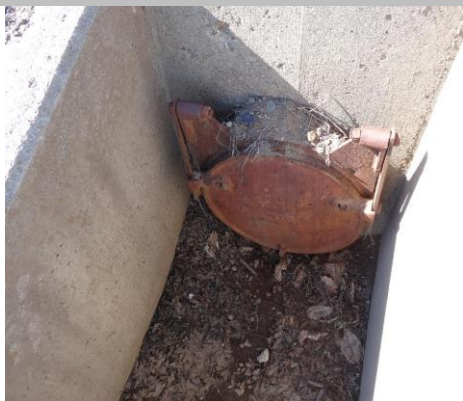
Photo 1 of 2 : UCIP_FA_2016_30294_55704.jpg

FS_ID:30294
DS_ID:19216
EP_NO: N/A
Repair Type: Non-Urgent
Crossing Status: Found
UCIP Comments: Inlet and outlet needs cleaning and clearing of debris.
FIELD_STRUCT_DESC: 24-inch CM pipe through levee, 8.5 feet below the crown. Flap gate on the waterward end. Concrete "U" headwalls on both ends. Grouted riprap apron on the landward end. Grouted riprap spillway on the waterward end. O&M Manual Sac 504, May 1965.
FS Date: 2/20/2014

WS view: U type concrete headwall, flapgate on levee slope.

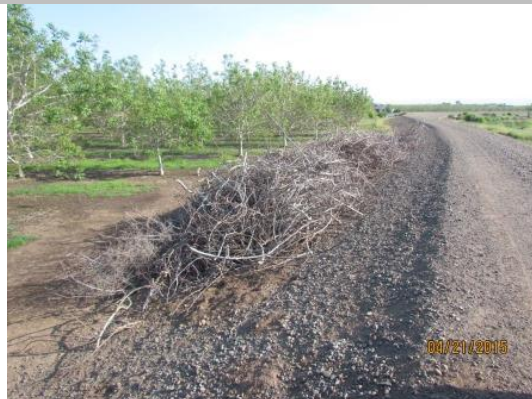
Photo 1 of 2 : FA_2016_NA0003_64_31_20160823_00015.jpg

View of the prunings along the landside slope.

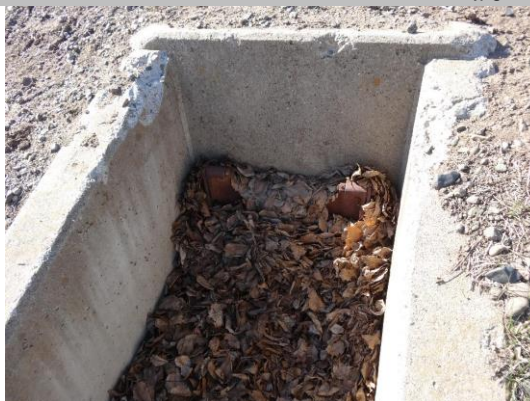
Photo 1 of 2 : UCIP_FA_2016_30295_55706.jpg

WS view: U type concrete headwall, flapgate on levee slope. Vegetation debris blocking the outlet.

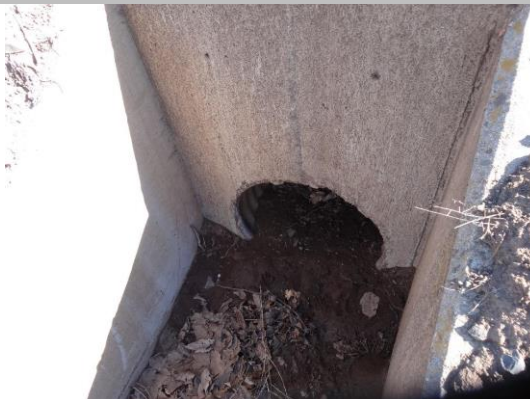
Photo 2 of 2 : UCIP_FA_2016_30311_55742.jpg

LS view: U type concrete headwall and CMP on levee slope.

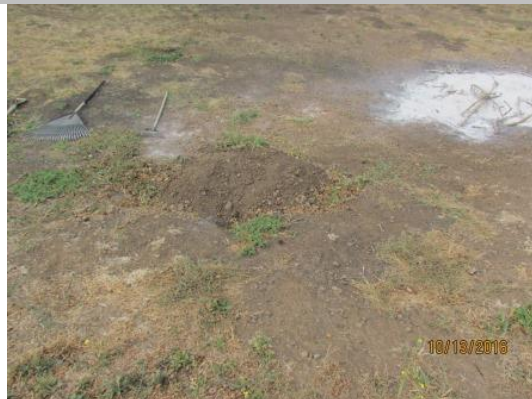
Photo 1 of 1 : FA_2016_NA0003_64_51_20161019_00059.jpg

View of the rodent holes along the landside slope.

LM Start	4.03	Rating **	M	Issue No.	51
LM End	4.03	Issue Type +	Ma	Location *	LS
Category	Earthen Levee			GPS Latitude/Longitude	
				Start	End
Item	Animal Control			39.771877 °	39.771877 °
				-121.899441 °	-121.899441 °
DWR ID	DWR_NA0003_01_f_2016_51				
Comment Code					
A1 : Exterminate rodents and backfill and compact or grout burrows.					
Inspector Comment

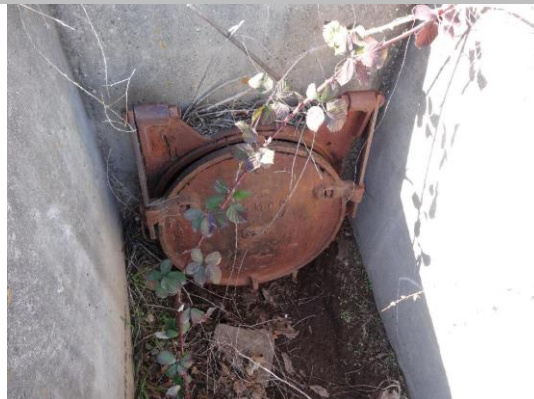
Photo 1 of 2 : UCIP_FA_2016_30312_55745.jpg

WS view: U type concrete headwall, pipe, and flapgate on levee slope. Vegetation debris blocking outlet.

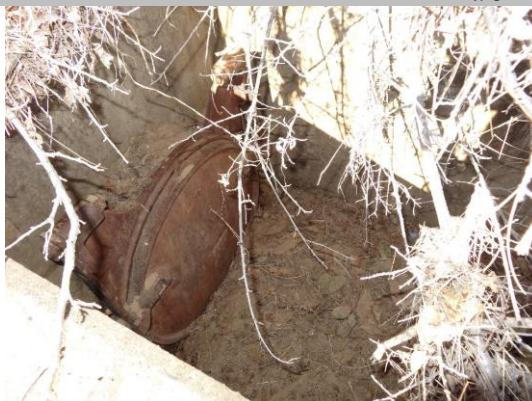
Photo 1 of 2 : UCIP_FA_2016_30388_55891.jpg

WS view: U type concrete headwall, pipe, and flapgate on levee slope. Vegetation/soil debris blocking outlet.

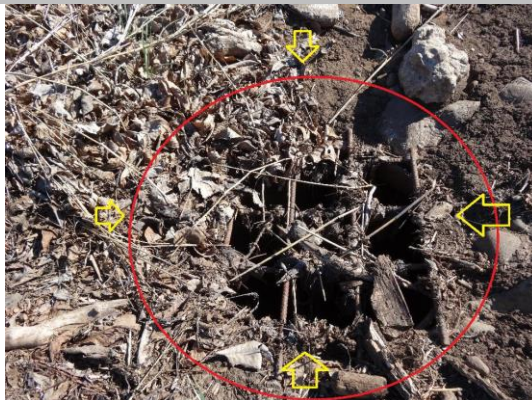
Photo 2 of 2 : UCIP_FA_2016_30388_55890.jpg

LS view: Underground CM standpipe intake with steel grit on levee toe.

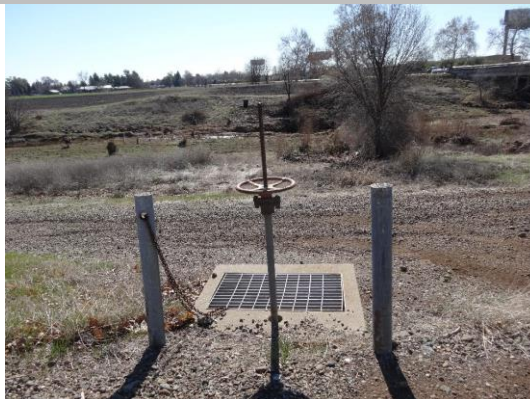
Photo 1 of 2 : UCIP_FA_2016_30368_55861.jpg

WS view: slide gate in concrete box on levee slope.

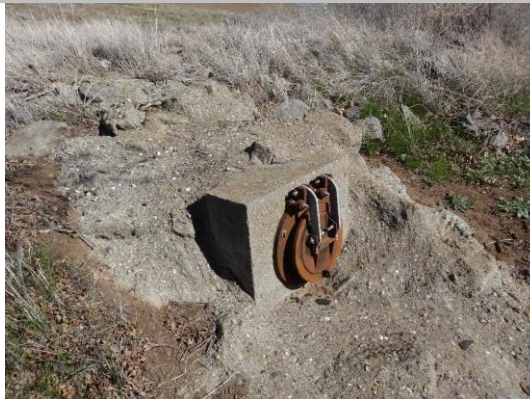
Photo 2 of 2 : UCIP_FA_2016_30368_55860.jpg

WS view: concrete headwall and flapgate on levee slope.

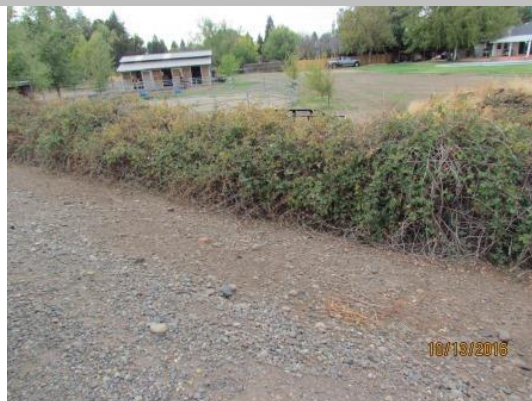
Photo 1 of 1 : FA_2016_NA0003_64_22_20161019_00063.jpg

LM Start	5.96	Rating **	M	Issue No.	22
LM End	5.96	Issue Type +	En	Location *	LS
Category	Earthen Levee			GPS Latitude/Longitude	
				Start	End
Item	Vegetation			39.793116 °	39.793116 °
				-121.887296 °	-121.887296 °
DWR ID	DWR_NA0003_01_f_2016_22				
Comment Code					
V6 : Landscaping					
Inspector Comment					
Blackberry bramble

View of the blackberries blocking visibility and access.

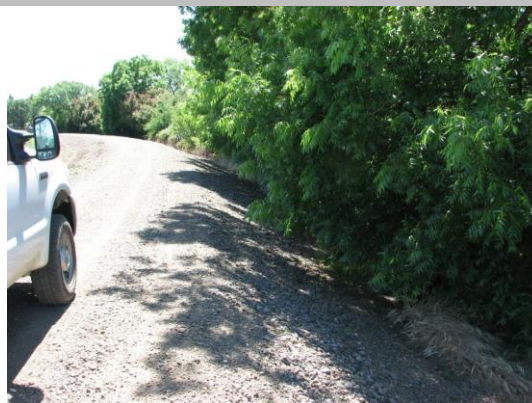
Photo 1 of 1 : FA_2016_NA0003_64_37_20160823_00021.jpg

LM Start	5.98	Rating **	U	Issue No.	37
LM End	6.07	Issue Type +	En	Location *	LS
Category	Earthen Levee			GPS Latitude/Longitude	
				Start	End
Item	Vegetation			39.793411 °	39.794580 °
				-121.887310 °	-121.886759 °
DWR ID	DWR_NA0003_01_s_2016_37				
Comment Code					
V6 : Landscaping					
Inspector Comment					
Various overgrown vegetation completely obscuring landside toe visibility.

04/25/2016: Trim trees on L/S slope.

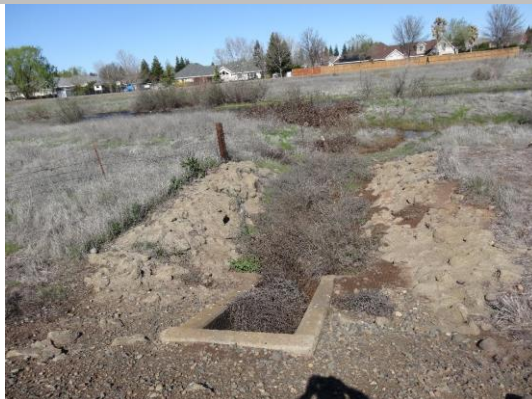
Photo 1 of 2 : UCIP_FA_2016_31667_57968.jpg

WS view: CMP culvert with U type concrete headwall. Vegetation debris blocking outlet box.

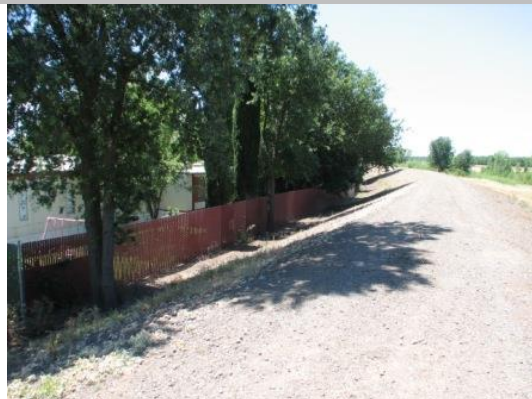
Photo 1 of 1 : FA_2016_NA0003_65_3_20160823_00002.jpg

LM Start	1.49	Rating **	U	Issue No.	3
LM End	1.81	Issue Type +	En	Location *	LS
Category	Earthen Levee			GPS Latitude/Longitude	
				Start	End
Item	Encroachments			39.782773 °	39.778972 °
				-121.888178 °	-121.891563 °
DWR ID	DWR_NA0003_02_s_2012_3				
Comment Code					
FE : Fence					
Inspector Comment					
The fence is within the easement.

View of the fence along the landside toe of the levee.

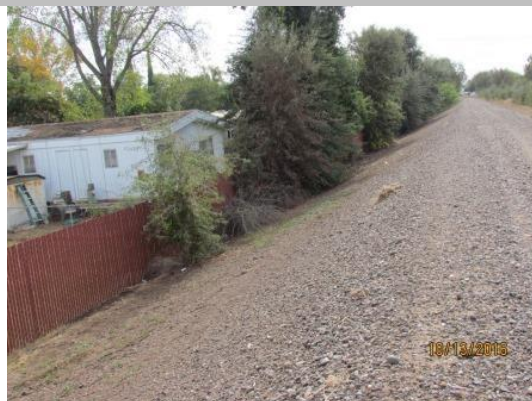
Photo 1 of 1 : FA_2016_NA0003_65_31_20161019_00017.jpg

View of the trees along the landside toe.

LM Start	1.54	Rating **	M	Issue No.	31
LM End	1.74	Issue Type +	Ma	Location *	LS
Category	Earthen Levee			GPS Latitude/Longitude	
				Start	End
Item	Trim / Thin Trees			39.782175 °	39.779667 °
				-121.888813 °	-121.890613 °
DWR ID	DWR_NA0003_02_f_2016_31				
Comment Code					
T1 : Trim trees to at least five feet above ground level.					
Inspector Comment

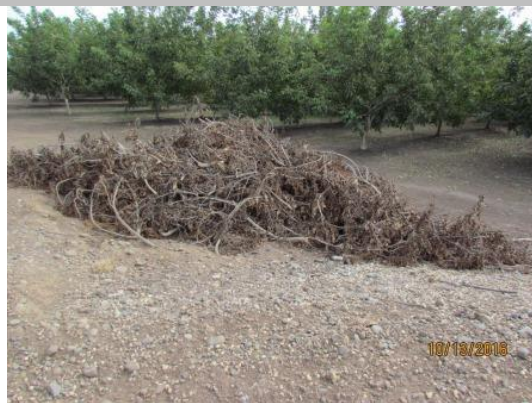
Photo 1 of 1 : FA_2016_NA0003_65_33_20161019_00019.jpg

View of the prunings along the landside toe.

LM Start	3.95	Rating **	M	Issue No.	33
LM End	3.95	Issue Type +	En	Location *	LS
Category	Earthen Levee			GPS Latitude/Longitude	
				Start	End
Item	Encroachments			39.755681 °	39.755681 °
				-121.910628 °	-121.910628 °
DWR ID	DWR_NA0003_02_f_2016_33				
Comment Code					
PR : Prunings					
Inspector Comment					
Remove prunings from the landside toe.

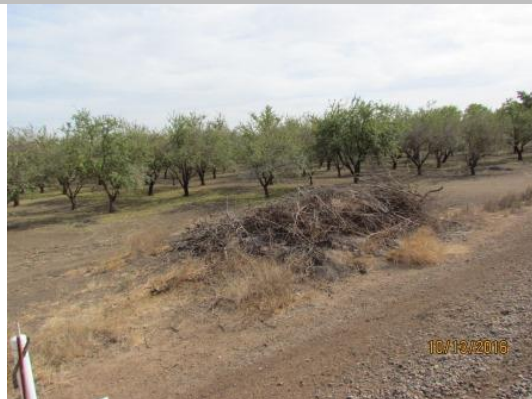
Photo 1 of 1 : FA_2016_NA0003_65_34_20161019_00020.jpg

View of the prunings along the landside toe.

LM Start	4.54	Rating **	M	Issue No.	34
LM End	4.54	Issue Type +	En	Location *	LS
Category	Earthen Levee			GPS Latitude/Longitude	
				Start	End
Item	Encroachments			39.749708 °	39.749708 °
				-121.917162 °	-121.917162 °
DWR ID	DWR_NA0003_02_f_2016_34				
Comment Code					
PR : Prunings					
Inspector Comment					
Remove prunings from the landside toe.

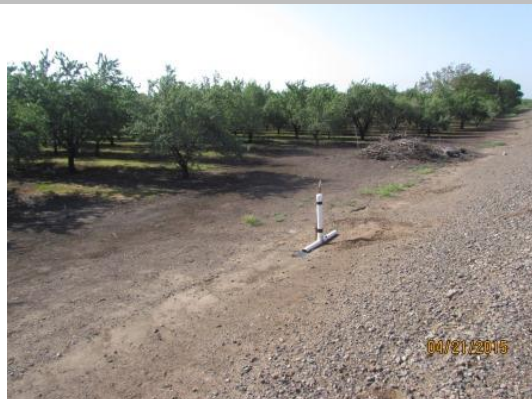
Photo 1 of 2 : FA_2016_NA0003_65_8_20160823_00004.jpg

LM Start	4.55	Rating **	A/W	Issue No.	8
LM End	4.55	Issue Type +	Ma	Location *	LS
Category	Earthen Levee			GPS Latitude/Longitude	
				Start	End
Item	Animal Control			39.749639 °	39.749639 °
				-121.917188 °	-121.917188 °
DWR ID	DWR_NA0003_02_f_2013_8				
Comment Code					
A1 : Exterminate rodents and backfill and compact or grout burrows.					
Inspector Comment					
Butte County has been grouting the rodent holes.

View of the bait station placed by the rodent hole.

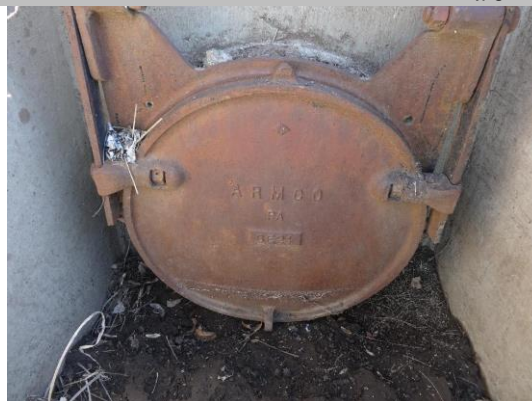
Photo 1 of 2 : UCIP_FA_2016_31028_56913.jpg

WS view: U type concrete headwall, pipe, and flapgate on levee slope.
Soil/mud on outlet box.

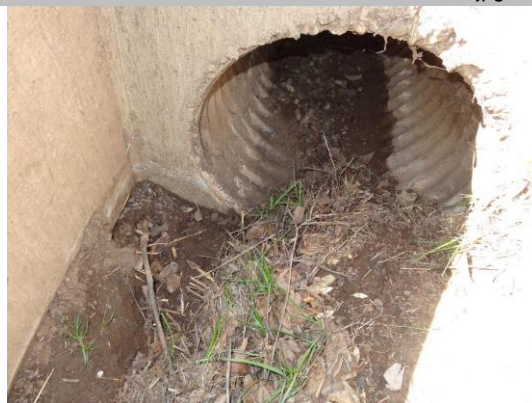
Photo 2 of 2 : UCIP_FA_2016_31028_56912.jpg

LS view: U type concrete headwall and CMP on levee slope.

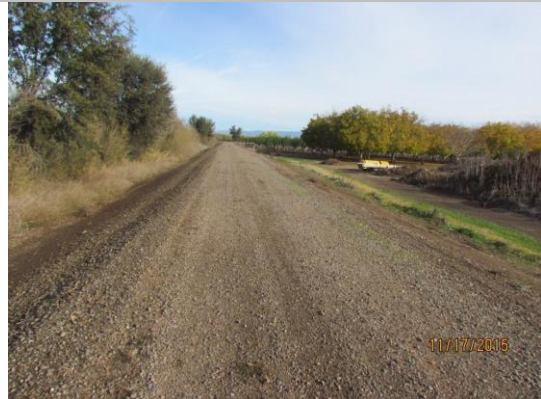
Photo 1 of 1 : FA_2016_NA0003_66_4_20161026_00001.jpg

LM Start	0.00	Rating **	A	Issue No.	4
LM End	0.00	Issue Type +	Ma	Location *	
Category	Earthen Levee			GPS Latitude/Longitude	
				Start	End
Item	Vegetation			39.733077 °	39.733077 °
				-121.930273 °	-121.930273 °
DWR ID	DWR_NA0003_02A_f_2016_4				
Comment Code					
Inspector Comment					
LMA is keeping grass and weeds off of levee slopes.

View of the levee crown.

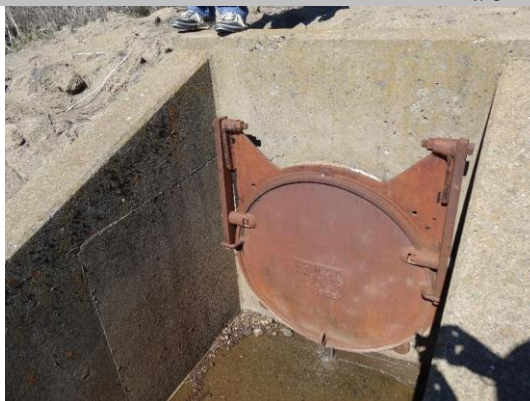
Photo 1 of 2 : UCIP_FA_2016_32103_58602.jpg

WS view: U type concrete headwall, pipe, and flapgate on levee slope.

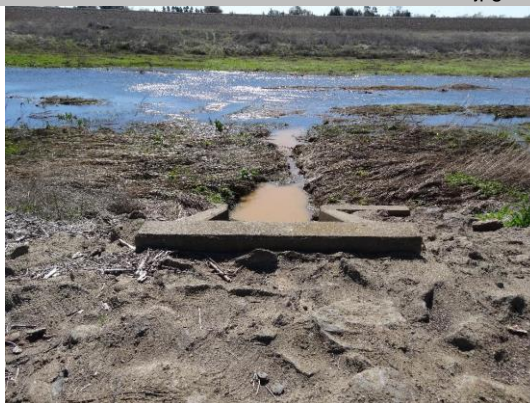
Photo 2 of 2 : UCIP_FA_2016_32103_58601.jpg

WS view: U type concrete headwall of CMP culvert on levee slope.
Grouted riprap levee slope and spillway.

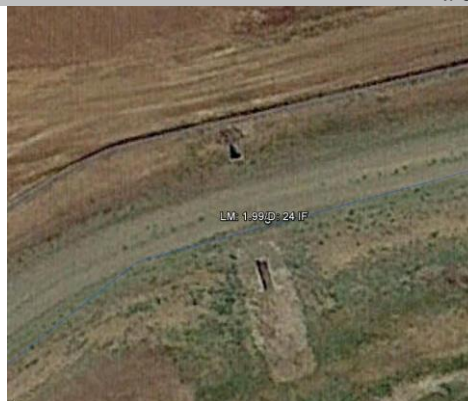
Photo 1 of 1 : UCIP_FA_2016_31900_58189.jpg

LM Start	1.96	Rating **	M	Issue No.	22
LM End	1.96	Issue Type +	En	Location *	LS
Category	Supplemental			GPS Latitude/Longitude	
				Start	End
Item	DWR UCIP Field Study			39.781714 °	39.781714 °
				-121.850868 °	-121.850868 °
DWR ID					
Comment Code					
Inspector Comment					
FS_ID:31900 DS_ID:19266 EP_NO: N/A Repair Type: Non-Urgent Crossing Status: Indicator Found UCIP Comments: Needs location confirmation, GPS reading has not taken due to access problem. FIELD_STRUCT_DESC: 24-inch CM pipe through the levee, 8.0 feet below the crown. Flap gate on the waterward end. Concrete "U" headwalls on both ends. Grouted riprap apron on the landward end. Grouted riprap spillway on the waterward end. O&M Manual Sac 504, May 1965. FS Date: 3/11/2014

Bird's eye view: concrete headwall visible on both sides of the levee.
Grouted riprap spillway on waterside.

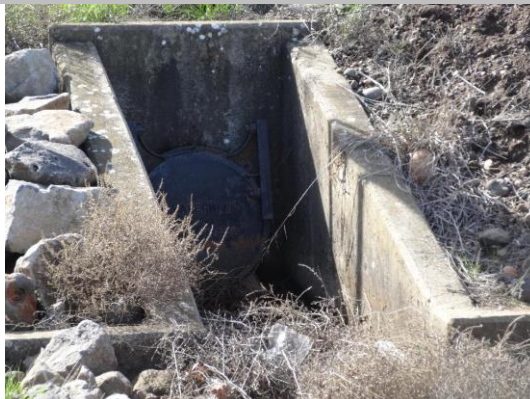
Photo 1 of 2 : UCIP_FA_2016_32124_58625.jpg

WS view: concrete headwall, pipe, and flapgate on levee slope.
Vegetation and mud on outlet box.

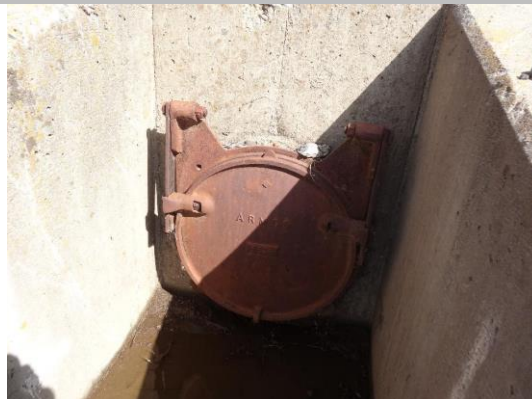
Photo 1 of 2 : UCIP_FA_2016_31856_58053.jpg

LM Start	3.50	Rating **	M	Issue No.	16 (cont)
LM End	3.50	Issue Type +	En	Location *	LS

WS view: U type concrete headwall, pipe, and flapgate on levee slope.
Soil/mud on outlet box.

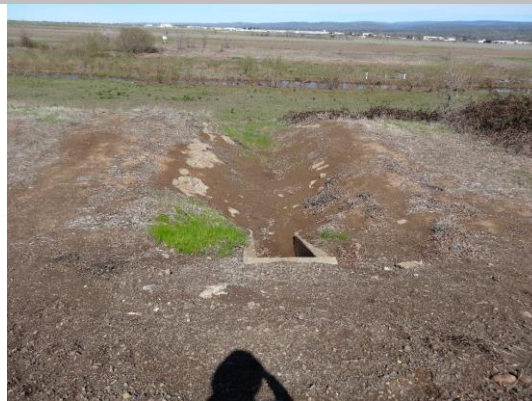
Photo 1 of 2 : UCIP_FA_2016_32026_58520.jpg

LM Start	0.27	Rating **	M	Issue No.	34
LM End	0.27	Issue Type +	En	Location *	LS
Category	Supplemental			GPS Latitude/Longitude	
				Start	End
Item	DWR UCIP Field Study			39.776554 °	39.776554 °
				-121.850730 °	-121.850730 °
DWR ID					
Comment Code					
Inspector Comment					
FS_ID:32026					
DS_ID:19279					
EP_NO: N/A					
Repair Type: Non-Urgent					
Crossing Status: Found					
UCIP Comments: Needs cleaning and clearing the culvert.					
FIELD_STRUCT_DESC: 24-inch CM pipe through the levee, 10.0 feet below the crown. Flap gate on the waterward end. Concrete "U" headwalls on both ends. Grouted riprap apron on the landward end. Grouted riprap spillway on the waterward end. O&M Manual Sac 504, May 1965.					
FS Date: 3/7/2014

WS view: concrete headwall and grouted riprap spillway on levee slope.

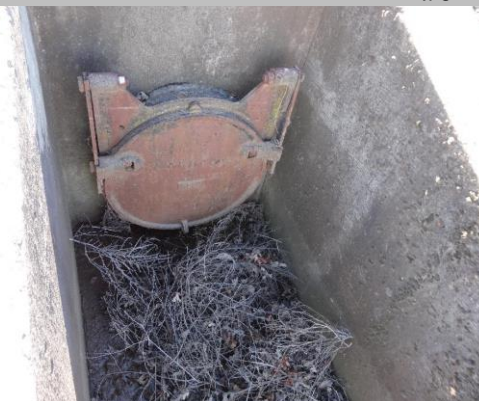
Photo 2 of 2 : UCIP_FA_2016_32026_58519.jpg

LM Start	0.27	Rating **	M	Issue No.	34 (cont)	
LM End	0.27	Issue Type +	En	Location *	LS	
Category	Supplemental			GPS Latitude/Longitude		
				Start	End	
Item	DWR UCIP Field Study			39.776554 °	39.776554 °	
				-121.850730 °	-121.850730 °	
DWR ID						
Comment Code						
Inspector Comment						
FS_ID:32026						
DS_ID:19279						
EP_NO: N/A						
Repair Type: Non-Urgent						
Crossing Status: Found						
UCIP Comments: Needs cleaning and clearing the culvert.						
FIELD_STRUCT_DESC: 24-inch CM pipe through the levee, 10.0 feet below the crown. Flap gate on the waterward end. Concrete "U" headwalls on both ends. Grouted riprap apron on the landward end.						
Grouted riprap spillway on the waterward end. O&M Manual Sac 504, May 1965.						
FS Date: 3/7/2014

WS view: U type concrete headwall and CMP on levee slope. Mud and vegetation debris on outlet box.

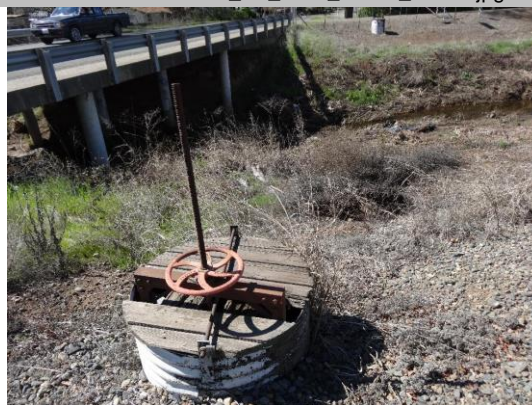
Photo 1 of 2 : UCIP_FA_2016_32025_58512.jpg

LM Start	0.33	Rating **	M	Issue No.	33
LM End	0.33	Issue Type +	En	Location *	LS
Category	Supplemental			GPS Latitude/Longitude	
				Start	End
Item	DWR UCIP Field Study			39.775926 °	39.775926 °
				-121.850647 °	-121.850647 °
DWR ID					
Comment Code					
Inspector Comment					
FS_ID:32025					
DS_ID:19280					
EP_NO: N/A					
Repair Type: Non-Urgent					
Crossing Status: Found					
UCIP Comments: Slide gate in a CMP riser. Vegetation debris and mud on inlet box.Needs cleaning and clearing the culvert.					
FIELD_STRUCT_DESC: 24-inch CM pipe through the levee and under the channel, 9.5 feet below the crown. Slide gate in CM pipe riser on the waterward slope. Concrete "U" headwall on the landward end. O&M Manual Sac 504, May 1965.					
FS Date: 3/7/2014

WS view: slide gate in CMP riser on waterside shoulder.

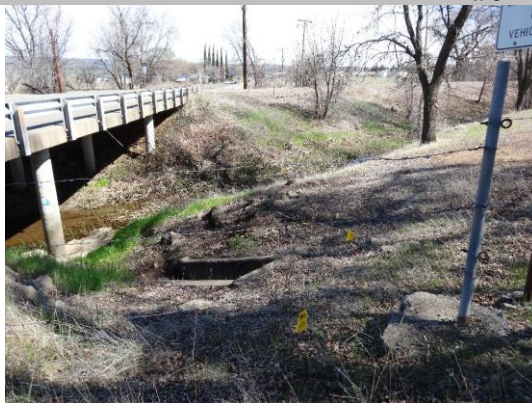
Photo 1 of 2 : UCIP_FA_2016_31946_58357.jpg

LM Start	0.92	Rating **	M	Issue No.	27
LM End	0.92	Issue Type +	En	Location *	LS
Category	Supplemental			GPS Latitude/Longitude	
				Start	End
Item	DWR UCIP Field Study			39.775729 °	39.775729 °
				-121.850950 °	-121.850950 °
DWR ID					
Comment Code					
Inspector Comment					
FS_ID:31946 DS_ID:19293 EP_NO: 15950 Repair Type: Non-Urgent Crossing Status: Indicator Found UCIP Comments: Only little gasoline indicator flags found on both sides of the levee and across the creek. FIELD_STRUCT_DESC: 6-inch-diameter high pressure gas main line under both levees and across channel of Dry Creek. 2 feet below the crown. Application No. 15950, 1992. FS Date: 3/7/2014

WS view: little gasline indicator (yellow flags) on both sides of the levee.

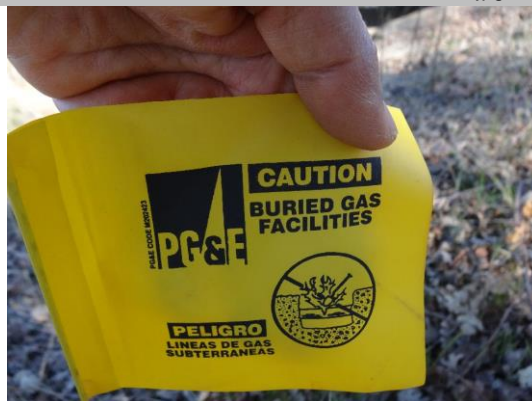
Photo 2 of 2 : UCIP_FA_2016_31946_58356.jpg

LM Start	0.92	Rating **	M	Issue No.	27 (cont)	
LM End	0.92	Issue Type +	En	Location *	LS	
Category	Supplemental			GPS Latitude/Longitude		
				Start	End	
Item	DWR UCIP Field Study			39.775729 °	39.775729 °	
				-121.850950 °	-121.850950 °	
DWR ID						
Comment Code						
Inspector Comment						
FS_ID:31946 DS_ID:19293 EP_NO: 15950 Repair Type: Non-Urgent Crossing Status: Indicator Found UCIP Comments: Only little gasoline indicator flags found on both sides of the levee and across the creek. FIELD_STRUCT_DESC: 6-inch-diameter high pressure gas main line under both levees and across channel of Dry Creek. 2 feet below the crown. Application No. 15950, 1992. FS Date: 3/7/2014

WS view: close up view of little gasline indicator.

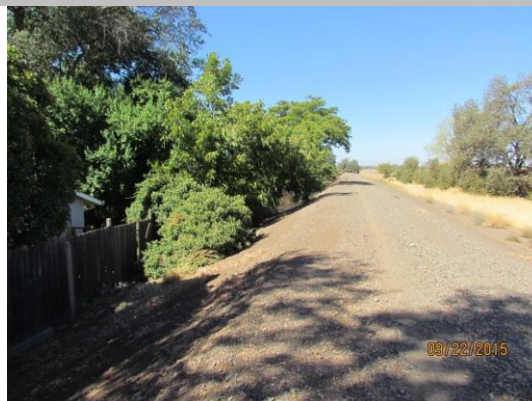
Photo 1 of 1 : FA_2016_NA0003_68_17_20160823_00004.jpg

LM Start	1.16	Rating **	M	Issue No.	17
LM End	1.22	Issue Type +	Ma	Location *	LS
Category	Earthen Levee			GPS Latitude/Longitude	
				Start	End
Item	Trim / Thin Trees			39.777128 °	39.777580 °
				-121.854763 °	-121.855612 °
DWR ID	DWR_NA0003_04_f_2015_17				
Comment Code					
T1 : Trim trees to at least five feet above ground level.					
Inspector Comment					
Remove the trees that are overhanging the levee slope.

View of the trees overhanging the levee slope.

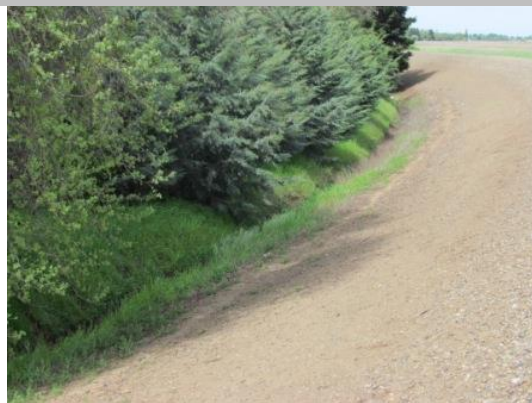
Photo 1 of 1 : FA_2016_NA0003_68_2_20160823_00002.jpg

LM Start	1.27	Rating **	M	Issue No.	2
LM End	1.36	Issue Type +	En	Location *	LS
Category	Earthen Levee			GPS Latitude/Longitude	
				Start	End
Item	Encroachments			39.778003 °	39.778378 °
				-121.856403 °	-121.857953 °
DWR ID	DWR_NA0003_04_s_2012_2				
Comment Code					
DT : Ditch					
Inspector Comment

View of ditch at the landside toe.

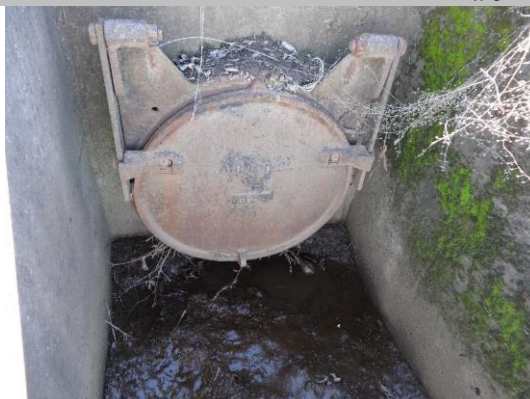
Photo 1 of 2 : UCIP_FA_2016_31964_58389.jpg

LM Start	1.35	Rating **	M	Issue No.	29 (cont)
LM End	1.35	Issue Type +	En	Location *	LS

WS view: U type concrete headwall and CMP on levee slope. Vegetation debris and mud in outlet box. Needs cleaning and clearing.

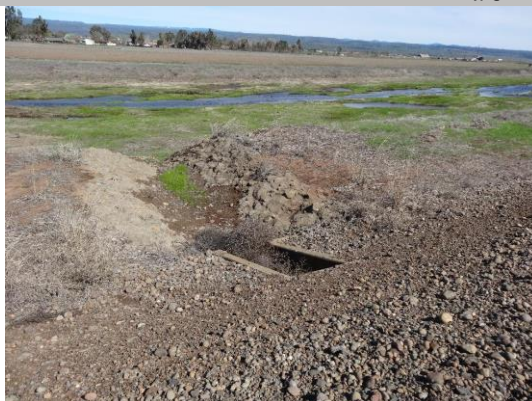
Photo 1 of 2 : UCIP_FA_2016_31966_58401.jpg

LM Start	2.47	Rating **	M	Issue No.	31 (cont)
LM End	2.47	Issue Type +	En	Location *	LS

WS view: U type concrete headwall and grouted riprap spillway on levee slope.
